Reliable POS Systems for Gas Stations

BXP-C100-C5 Series

Box computers with 11th Gen Intel® Core™ processor

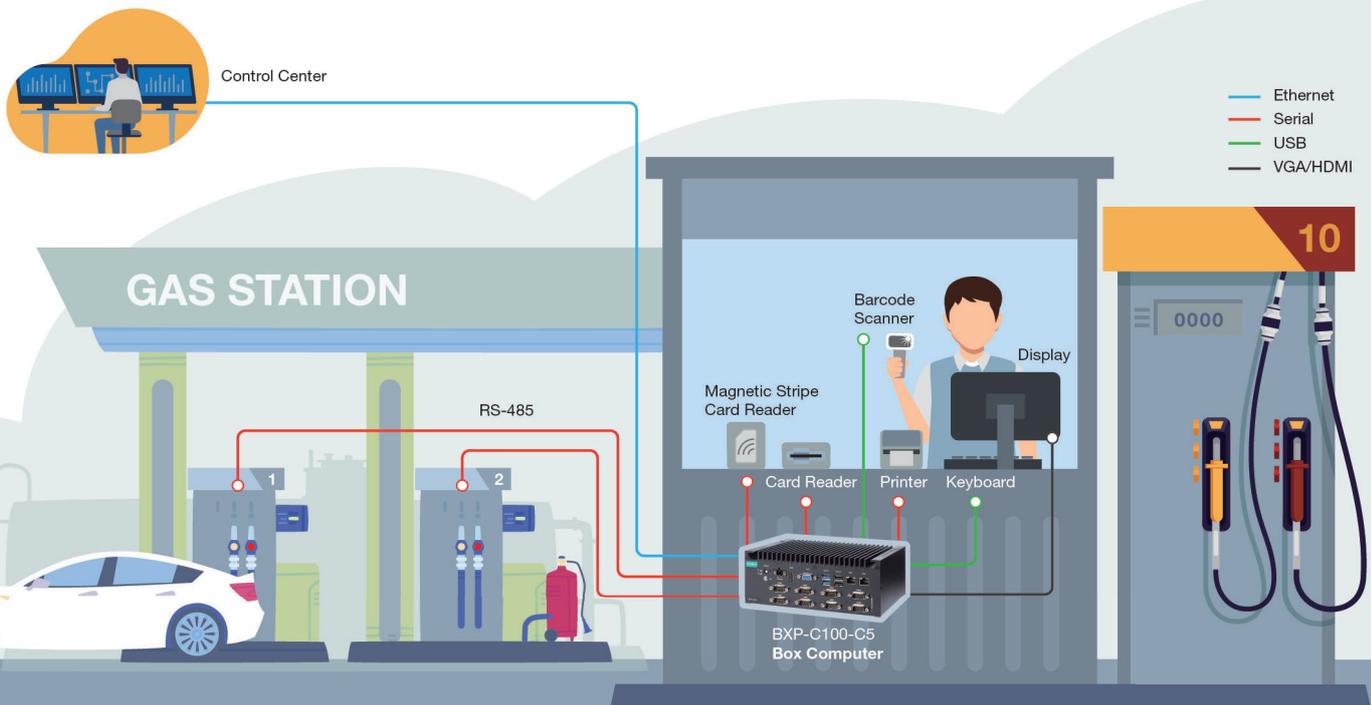
Measuring 210 x 166 x 83 mm, the BXP-C100-C5 box computers offer a wide array of communication interfaces for connections to fuel dispensers, card readers, barcode scanners, keyboard, mouse, printer, and display. A prominent durable power button eases every-day on/off operations.

The fanless design of the BXP-C100-C5 reduces the risk of mechanical failure while the sealed enclosure prevents dust, dirt, and airborne particles from entering and contaminating internal components, ensuring overall system stability and reliability.
